AUTHOR: [DR. J. JEFF SCHWEGMAN](#)

Introduction

Correctly Identifying the Failure

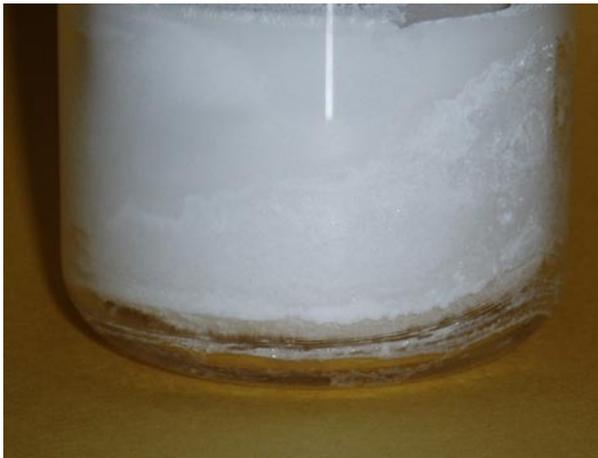
The different physical failures commonly observed in freeze-dried products are melt back and full or partial collapse. Melt back occurs when samples are warmed to secondary drying temperatures prior to completing primary drying. If primary drying is not allowed to go to completion, there will still be a slug of ice present at the bottom of the vial or tray. When the product is raised to the secondary drying temperature, the ice will melt leaving a dissolved layer of material at the bottom of the vial or tray. Figure 1 shows a vial of product that failed due to meltback.

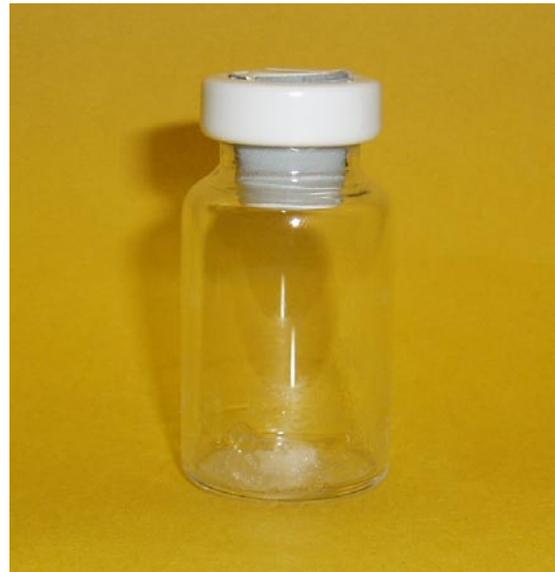
Figure 2

Full or partial collapse occurs when the product temperature exceeds or partially exceeds the glass transition temperature of the product. It must be understood that collapse can occur either during primary drying or during secondary drying if the ramp rate is too aggressive to secondary drying conditions. Figures 2 and 3 show full and partial collapse, respectively.

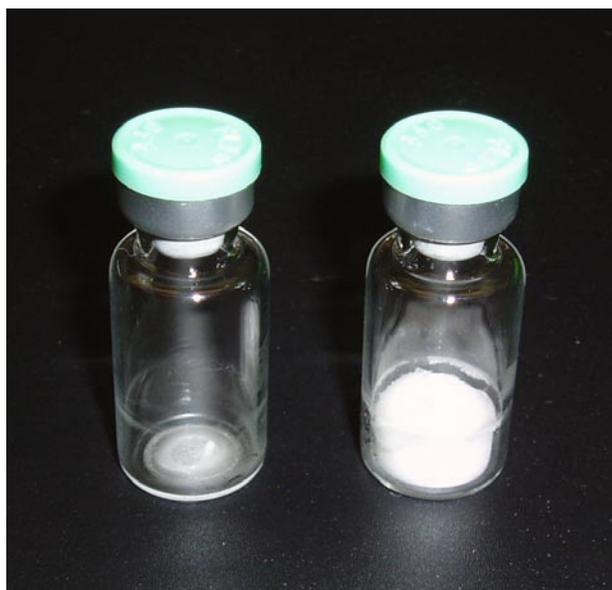
The development group was approached because samples of a lyophilized product were collapsing on stability both at 25°C and 40°C. The samples at 40°C were collapsing after 4 weeks, and the samples at 25°C were collapsing after 8 weeks. Figure 4 is an image showing a fully collapsed sample that was taken after 2 months at 25°C, and a control that had been kept at -20°C.

As discussed above, the first step is to identify the failure. In this particular case, the failure was collapse, which means that the product exceeded its Tg value on stability. The next step was to think about what influences the Tg in a product. It is understood that water acts as a plasticizer in amorphous solids. As the residual moisture increases, the Tg of the product goes down. Over time the Tg went below the storage temperature of the product and resulted in collapse. The next question to answer was how water was getting into the product. Upon further investigation, it was found that the moisture was coming out of the stopper over time. The stoppers used for this product were sterilized by running them through an autoclave. Under the high temperature, high steam conditions, the stoppers were absorbing moisture which they would release to the dry product (trying to reach equilibrium) over time. The Tg for this particular product dropped sharply in the presence of water vapor, so additional steps in the stopper preparation were needed. By adding a 4 hour dry heat step under vacuum, enough moisture

was pulled from the stoppers so that leaching into the product was no longer an issue.

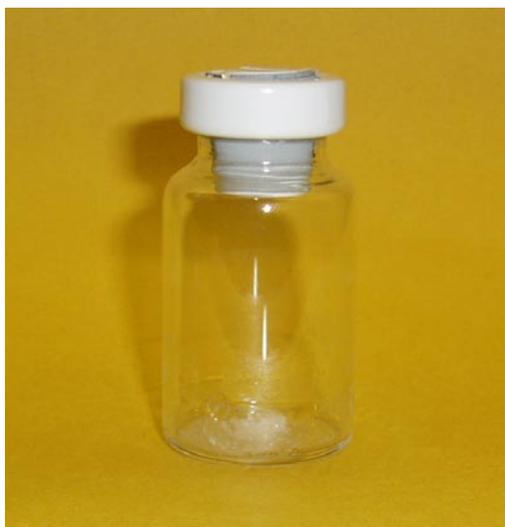
For this particular product, all of the samples that were being freeze-dried were completely collapsed after the cycle. Figure 5 shows an image of one of the samples that had fully collapsed. In addition to obtaining samples, the printout from the cycle, the analytical data from the testing, and the data from the thermal characterization study were all requested.

The failure was identified as collapse, and attributed to exceeding the products collapse temperature (either Tg' during primary drying or Tg during secondary drying). The printout from the cycle was inspected, and is shown in below in Figure 6 (note this does not show the secondary drying step).

The first thought to fix this problem might be to simply lower shelf temperature to keep the product below the Tg' until primary drying is complete. However, this product had some inherent problems that needed to be addressed prior to attempting another production run. The problem with this product is that it needs to be reformulated to improve the thermal properties. The Tg' for this product is excessively low (-45°C), and while a development scale freeze-dryer was able to successfully produce intact product, the less efficient, production dryer could not keep the product below its Tg' and collapse resulted. Even if a production freeze-dryer could keep this product cold enough, it should be reformulated for the simple fact that keeping a product this cold during primary drying significantly suppresses the sublimation rate. While intact product may be obtained, the cycle would be so long, it would be prohibitive as part of a manufacturing process. For this particular example, by removing some of the problematic excipients (sodium chloride), and substituting excipients with better thermal properties, it was possible to raise the Tg' for this product from -45°C to -28°C, and the product could now successfully be dried in a reasonable amount of time.

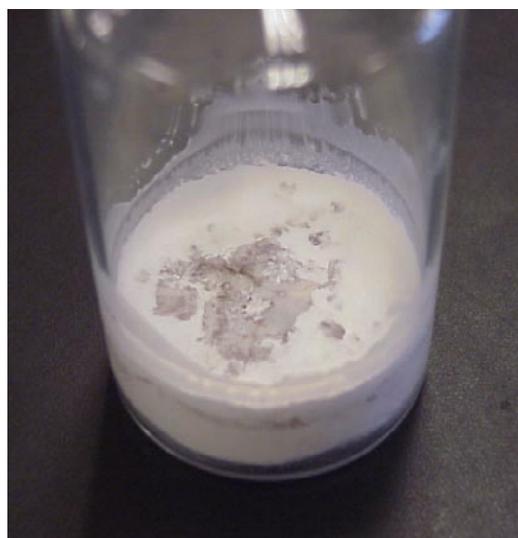
Figure 7

In addition to obtaining samples, the printout from the cycle, the analytical data from the testing, and the data from the thermal characterization study were all reviewed. The sample obtained is shown in Figure 7. The control was a solid white cake (not shown).

The failed samples had a purple brown discoloration on the top of the cakes, and there was a ring of meltback on the bottom.

The first step taken was to identify the failure. While it was initially unclear about the reason for the discoloration on the top of the cakes (it was suggested that oil or residual cleaning solution was dripping into some of the vials during filling), it was clear that the ring on the bottom of the vials was caused by meltback. Based on this, it was clear that these particular vials, for whatever reason, were not completing primary drying. It was known that this was not a dryer issue (edge effect, etc), because other vials next to the failed vials were acceptable.

engineering that some of vials were being overfilled prior to being loaded into the freeze-dryer. This would account for the samples melting back since there was now more ice to sublime, and would explain the increased potency in these samples. Upon further inspection of the filling line, a computer glitch was found which caused an additional half dose to be filled into the vials. Occasionally during a filling operation, the operators must stop the line to correct a problem (tipped over vials, improperly seated stoppers, etc). When the filling process was restarted, the computer became confused and would fill half of a dose in several vials that had already received a full dose. The discoloration was later determined to be due to the aggressiveness of the secondary drying phase. This particular molecule was very robust in regards to temperature, so secondary drying took place with a shelf temperature of 60°C. For the vials that melted back, the water would boil under the vacuum, percolate up through the product, and quickly degrade. One of the degradation products that formed happened to be colored (purple brown).
